**SEMI-AUTO SLIDING DOOR KIT**

Report No. : HL90167A/2018

Test Requested: Durability Test

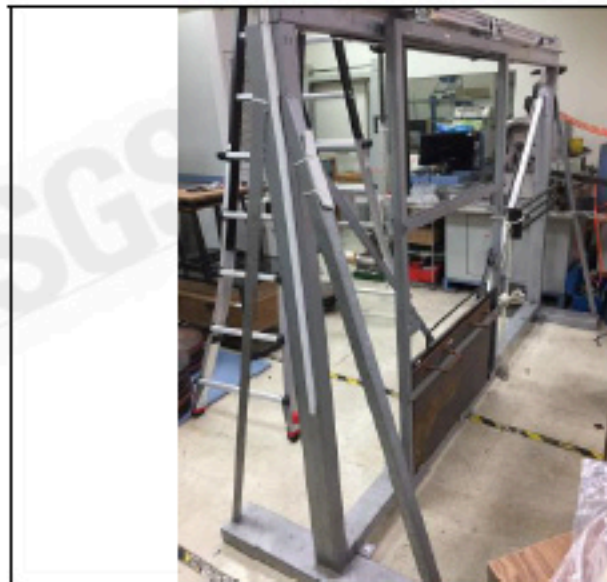
Photo A: Appearance of the sample

- (a) Secure the sliding door on the testing frame.
- (b) Apply a pulling force to the sliding door for a stroke of 84 cm then release the force to allow it return to the original position as a cycle.
- (c) A cycle consists a forward and backward, check the function of sliding door whether damage or not each 10,000 cycles at the frequency of 8 cycles per minute.
- (d) The weight of tested door: 94 kg

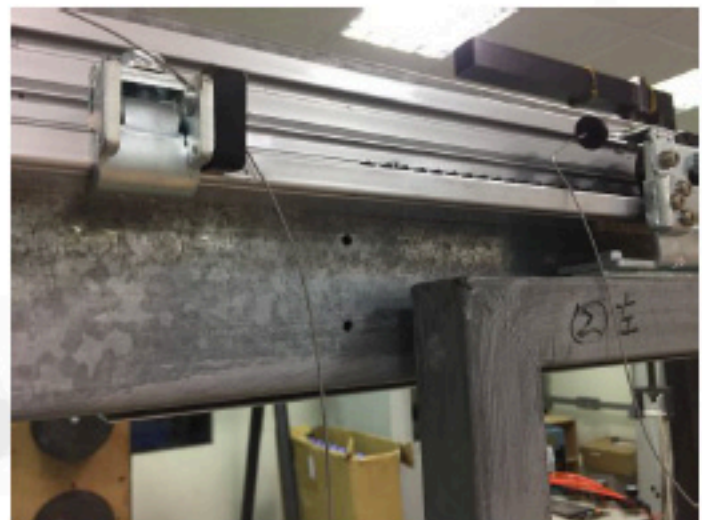
Photo B: After testing

140,000	The return function of sliding door is normal; no visual damage was found after testing.
	150,000	The return function of sliding door is normal; no visual damage was found after testing.
	160,000	The return function of sliding door is normal; no visual damage was found after testing.
	166,000	The return function of sliding door is abnormal after testing. (Photo B)
